PICTORIAL ESSAY

Endovascular Management of Iatrogenic Neck Vascular Injury after Central Venous Catheterisation

SC Wong, SY Lam, SKH Wong, HF Chan, LF Cheng

Department of Radiology, Princess Margaret Hospital, Hong Kong SAR, China

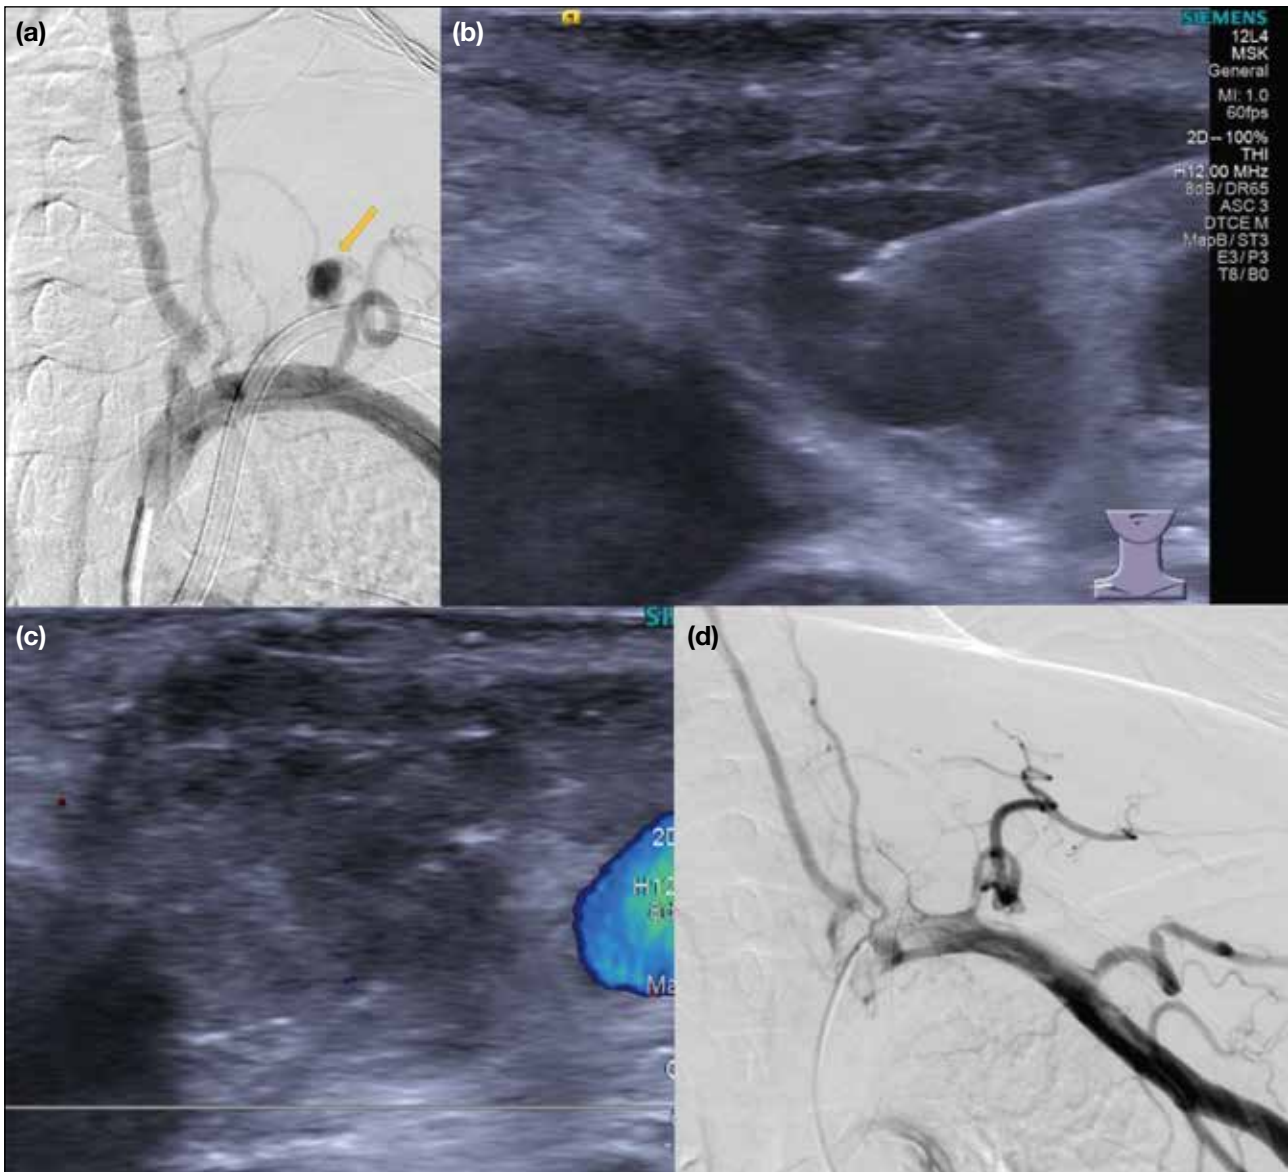
Figure 4. Case 4. Left thyrocervical trunk pseudoaneurysm after left internal jugular vein catheterisation. Digital subtraction angiography (a) shows a pseudoaneurysm (arrow) arising from the left thyrocervical trunk. A trial of endovascular catheterisation of the pseudoaneurysm for coiling was unsuccessful due to tortuous feeding vessels. (b and c) A percutaneous thrombin injection of 1,250 IU was performed under ultrasound guidance and real-time monitoring until complete sac thrombosis with loss of colour Doppler flow signal was carried out. (d) A subsequent left subclavian angiogram confirmed successful embolisation of the pseudoaneurysm.
