PICTORIAL ESSAY

Magnetic Resonance Imaging of Anterior Cruciate Ligament Repair and Complications: a Pictorial Essay

Department of Radiology, Princess Margaret Hospital, Laichikok, Hong Kong

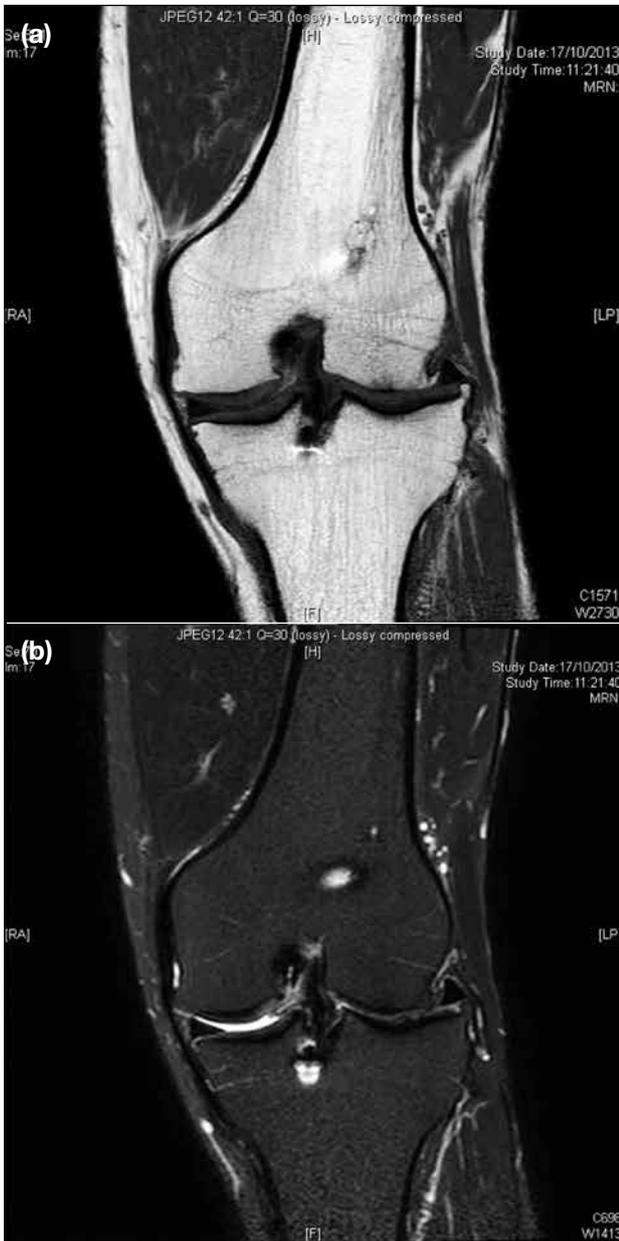
Figure 2. Anterior cruciate ligament graft impingement in a 34-year-old man. Coronal T1 (a) and coronal short tau inversion recovery (b) magnetic resonance images showing a laterally positioned tibial tunnel, with bowing and impingement on anterior cruciate ligament graft by the lateral femoral condyle. (Courtesy of Dr KF Tam, Department of Radiology, North District Hospital)

The position of tibial tunnel is the most important factor contributing to graft impingement.³ The patient having ACL graft impingement is typically presented with decreased range of movement. Radiologically, MRI will show a malpositioned tibial tunnel with the graft bowed and impinged on by the anterior-inferior portion of the intercondylar notch or lateral femoral condyle (Figures 2 and 3). Increased signal intensity can be demonstrated within the distal two-thirds of the graft. If untreated, graft rupture may result. Graft impingement is treated by notchplasty, which comprised of resection of portion of intercondylar notch.

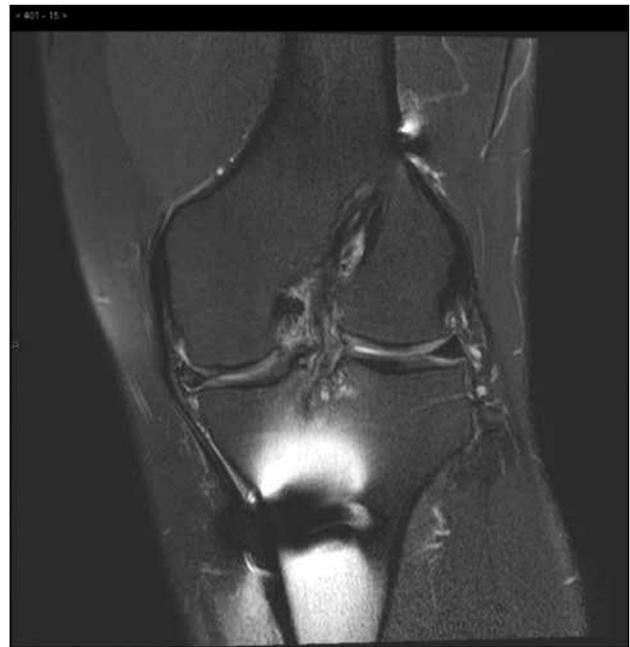
Figure 3. Anterior cruciate ligament graft impingement in a 23-year-old man. Coronal T2 fat-saturated magnetic resonance image showing impingement on anterior cruciate ligament graft by the lateral femoral condyle, with increased T2 signal in anterior cruciate ligament graft. (Courtesy of Dr Ryan Lee, Department of Radiology, Prince of Wales Hospital)

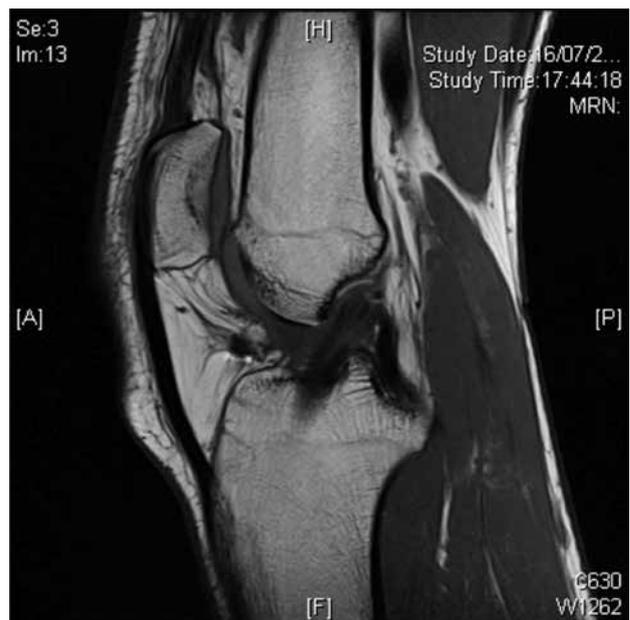
Figure 4. Small cyclops lesion in a 24-year-old man. Sagittal T1 magnetic resonance image showing a localised low-signal fibrotic nodular focus (0.7 cm) within the posterior Hoffa's fat pad, consistent with a small cyclops lesion.

Arthrofibrosis is another complication causing decreased range of movement after ACL reconstruction. Arthrofibrosis involves development of fibrous scar tissue within and around the synovium. It can be classified into two forms, diffuse and focal. In diffuse form, ill-defined or even mass-like area with low signal intensity surrounding the graft. A specific focal form of arthrofibrosis is located at the anterior part of the intercondylar space, commonly referred as a “cyclops lesion” (Figure 4). Radiologically, a nodule (typically 10-15 mm) of low signal intensity is seen anterior of the graft, near the tibial insertion. It is treated by arthroscopic excision.

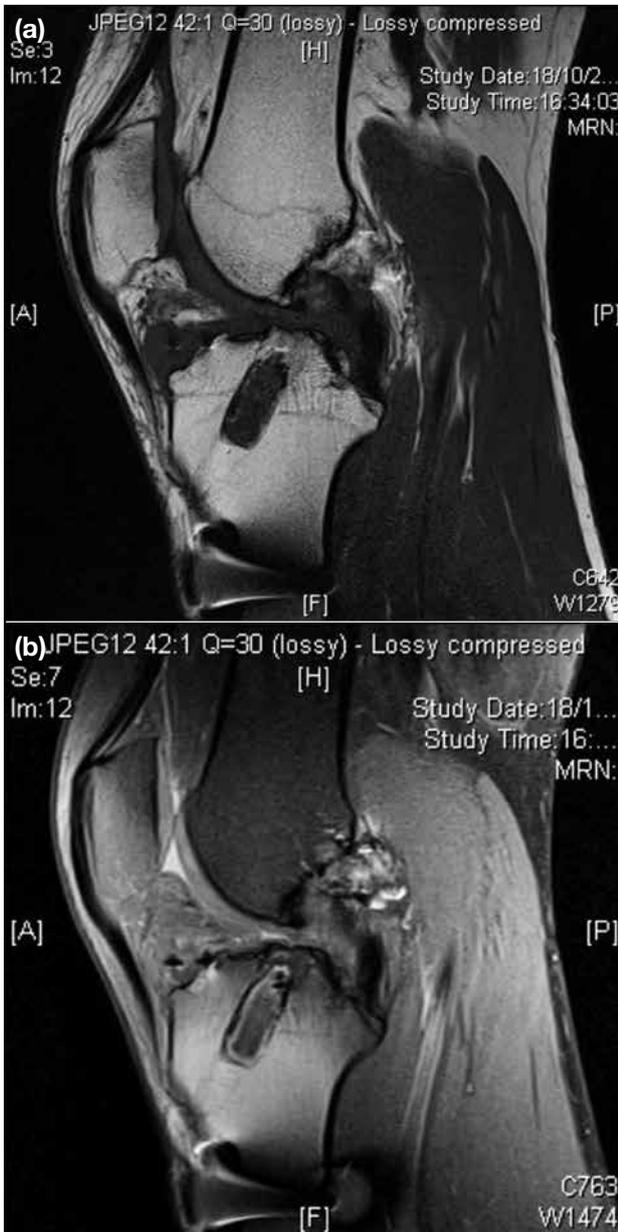
Figure 5. Complete anterior cruciate ligament graft tear in a 37-year-old man. Sagittal T1 (a) and proton density-weighted (b) magnetic resonance images showing discontinuity of fibres of anterior cruciate ligament graft, consistent with complete tear.

Graft rupture may happen “spontaneously” due to graft impingement or as a result of injury. Radiologically, increased signal intensity similar to that of fluid, fibre discontinuity, and possibly thinning of the graft are seen on T2-weighted sequences (Figure 5). Secondary signs, including anterior tibial translation and uncovering of posterior horn of lateral meniscus, are sometimes present. ACL re-reconstruction is the treatment of choice.
