PICTORIAL ESSAY

Multimodality Imaging of Breast Augmentations: A Pictorial Essay

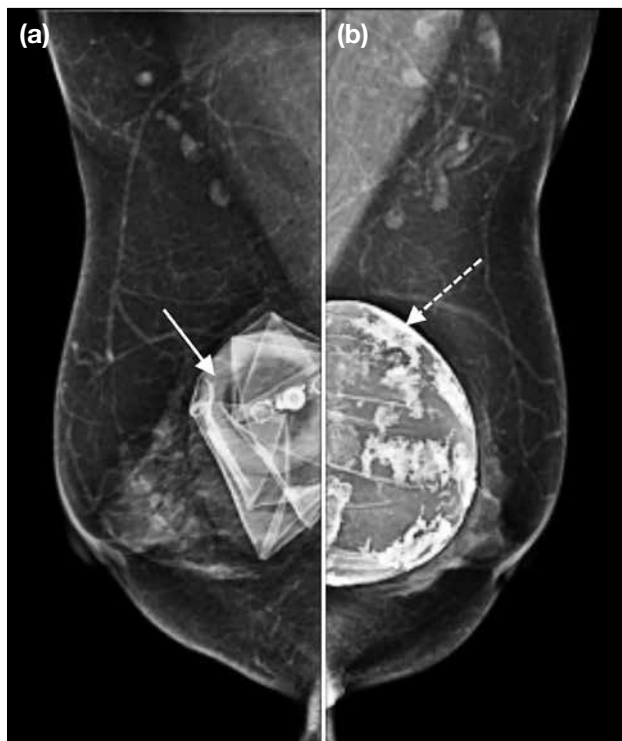
Figure 9. Bilateral subglandular saline implants. (a) Mammography showing that the right breast implant is collapsed, suggestive of implant rupture (solid arrow). (b) The left breast implant appears spherical, with peri-implant capsular calcifications (dashed arrow), suggestive of capsular contracture.

Some radiological features can aid in the diagnosis of capsular contracture. Instead of the normal oval shape, the implants appear more rounded in shape, with an increase in anteroposterior diameter (Figure 8).¹⁰ Also, visible capsular calcifications might develop due to local inflammation and fibrosis occurring as the implant ages (Figure 9).^{11,12}

On MG, intracapsular rupture appears as progressive contour deformity and undulation of implant shell (Figure 9).³ USG can also demonstrate a ‘stepladder sign’, due to the collapsed and infolded elastomer shell producing multiple thin echogenic lines parallel to the probe surface, which is equivalent to the ‘linguine sign’ on MRI.³

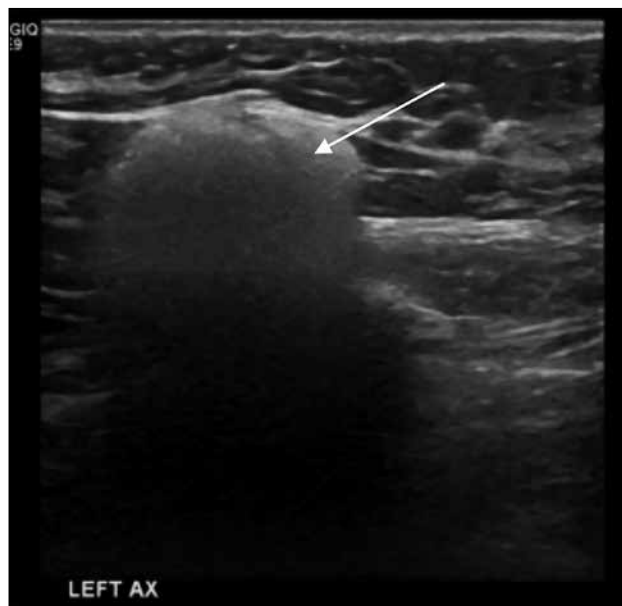
Figure 13. Ultrasonography showing an enlarged left axillary node (arrow) with posterior shadowing representing silicone lymphadenopathy. Free silicone appears echogenic lesion with a well-defined anterior border and posterior acoustic shadowing. Note that silicone lymphadenopathy can also be encountered in physical transudation of silicone through an intact implant capsule into the surrounding tissue and lymphatics, i.e., a 'gel bleed'.

A 'gel bleed' is defined as microscopic silicone transudation through an intact implant shell. It is due to the chemical affinity of the silicone gel for the silicone elastomer of the implant shell.^{19,20} This would appear as extracapsular echogenic silicone (e.g., in the axilla or more distant sites) on USG (Figure 13) and MRI with posterior acoustic shadowing.¹⁸
